# Supersonic Particle Deposition for Repair and Corrosion Protection of Mg Gearboxes

**ASETSDefense Work Shop**  
**Sept. 2, 2009**

**Brian M. Gabriel, Phillip F.  
Leyman, Dennis J. Helfritch,  
and Victor K. Champagne\***  
**ARL Center for Cold Spray**

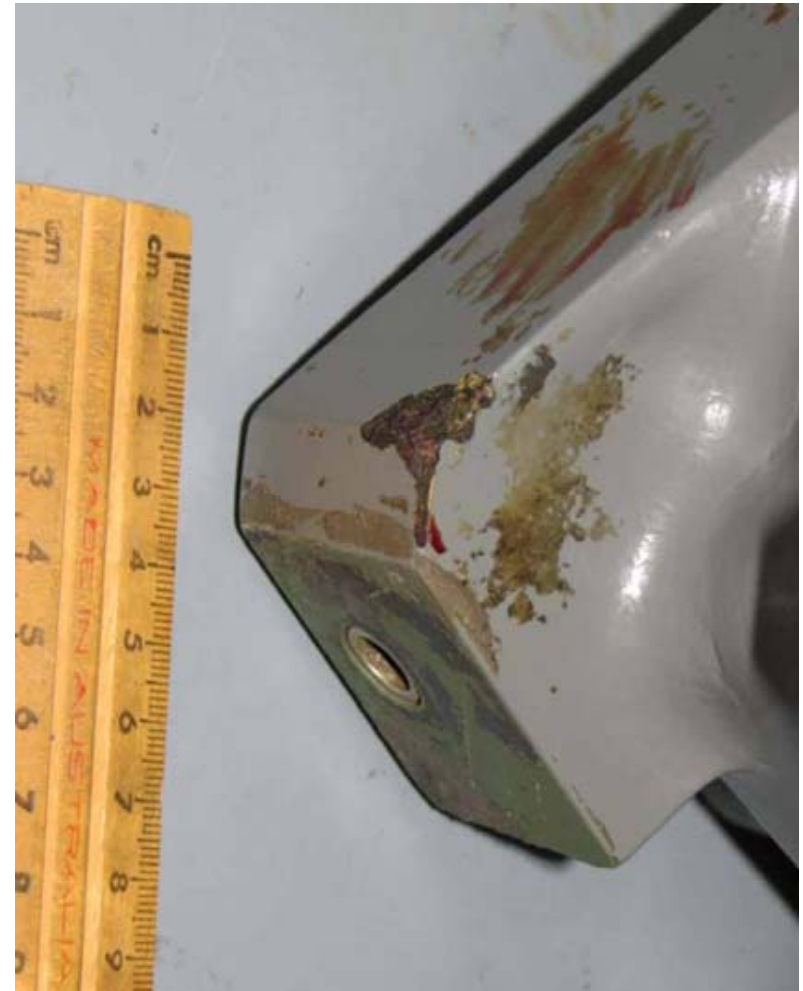
*Exterior corroded area on one of the as-received IGB pads*

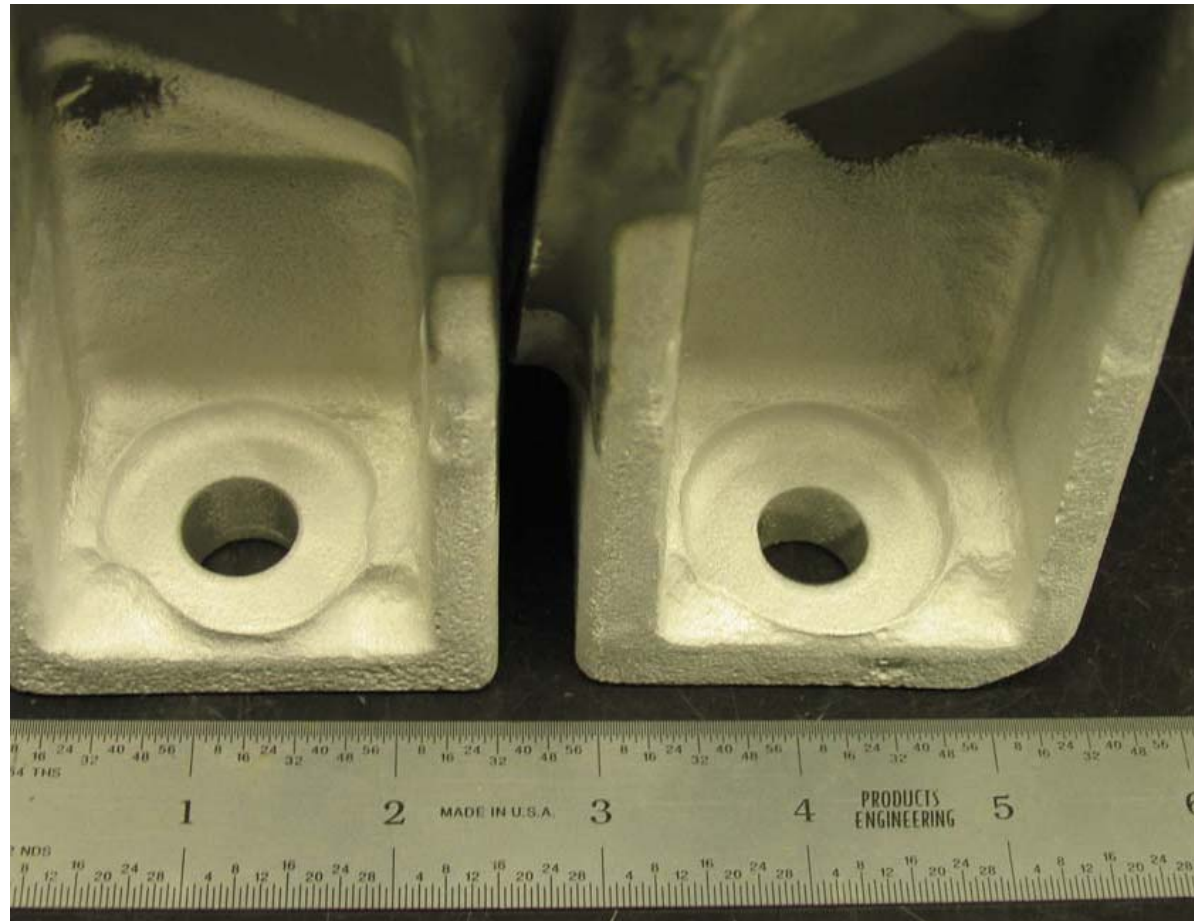
*CP Al Cold Spray*

## *Interior section of IGB pads coated with CP-aluminum*

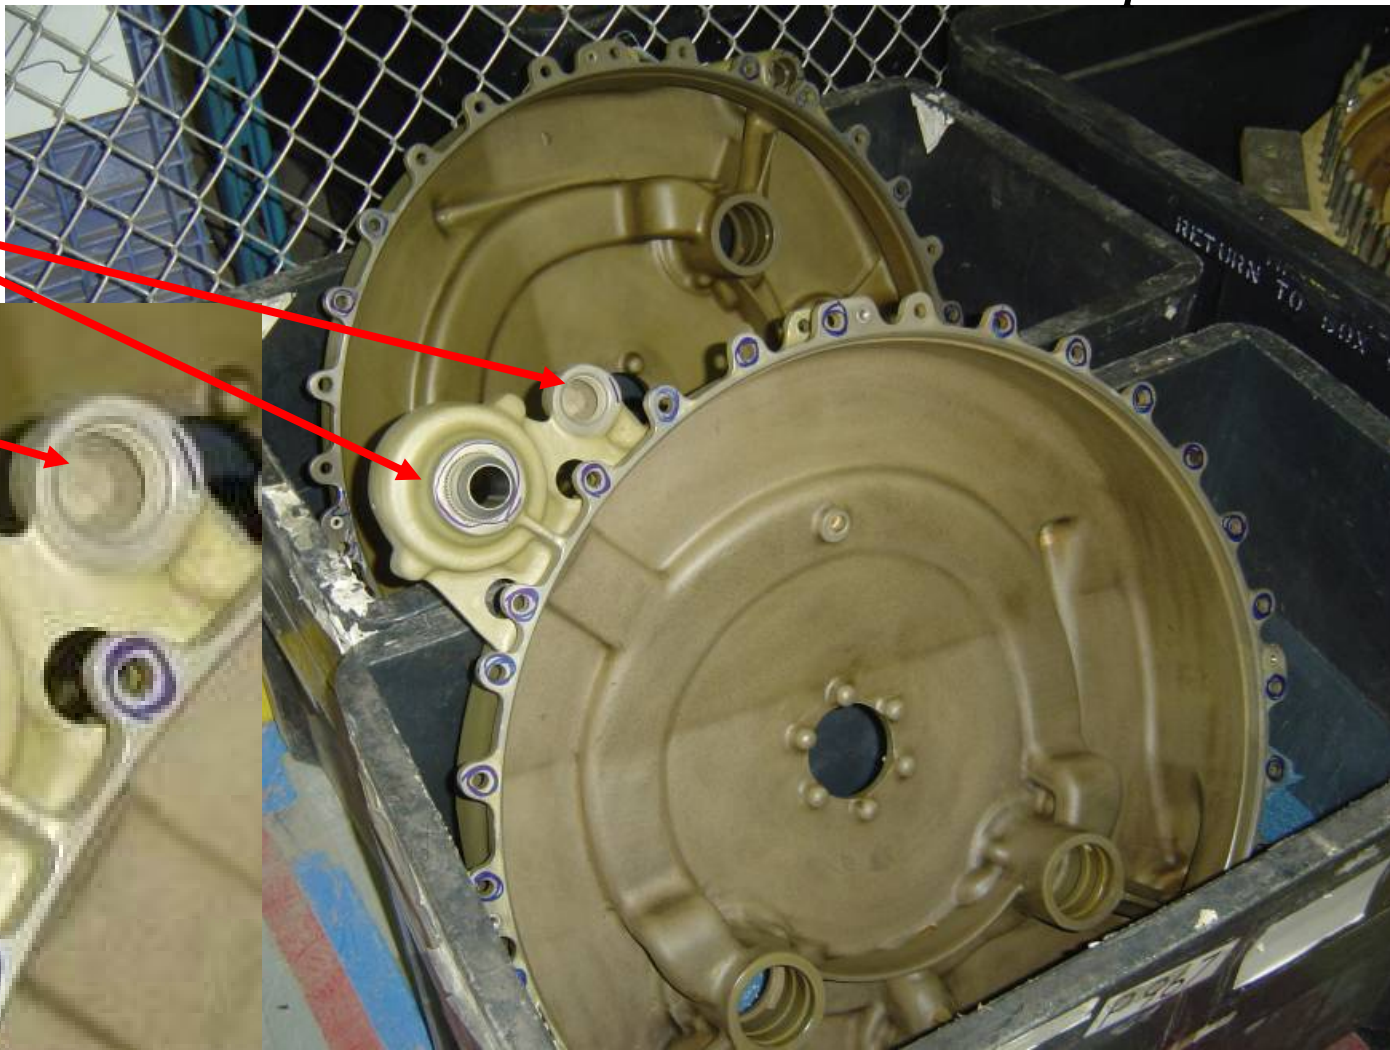
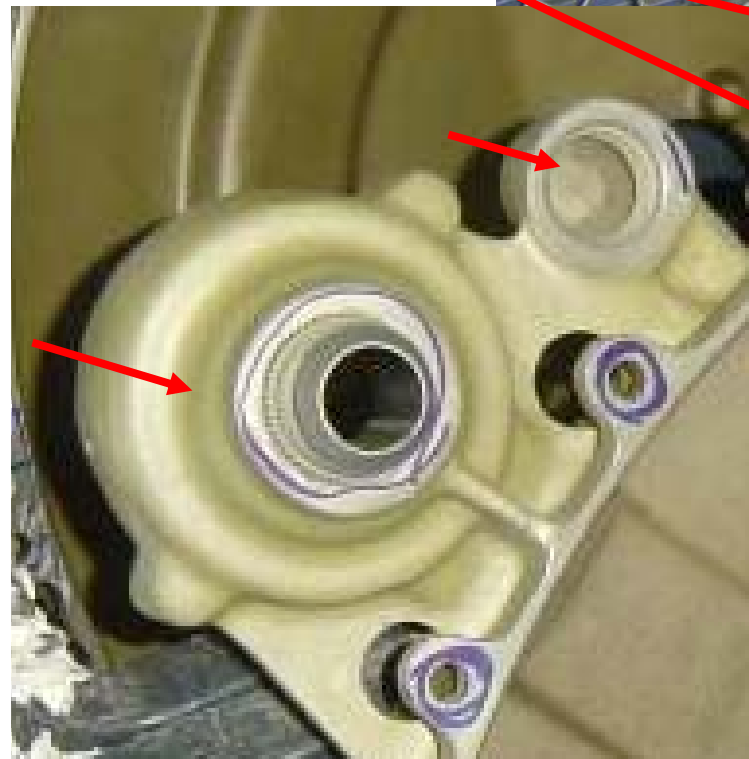
*Filter Bowl Mount*

*Cavities collect water*
